SIGACT BRIEF

MIA MORTAR ATTACK – 01 JANUARY 2019

01 January 2019

UNMAS | SOMALIA

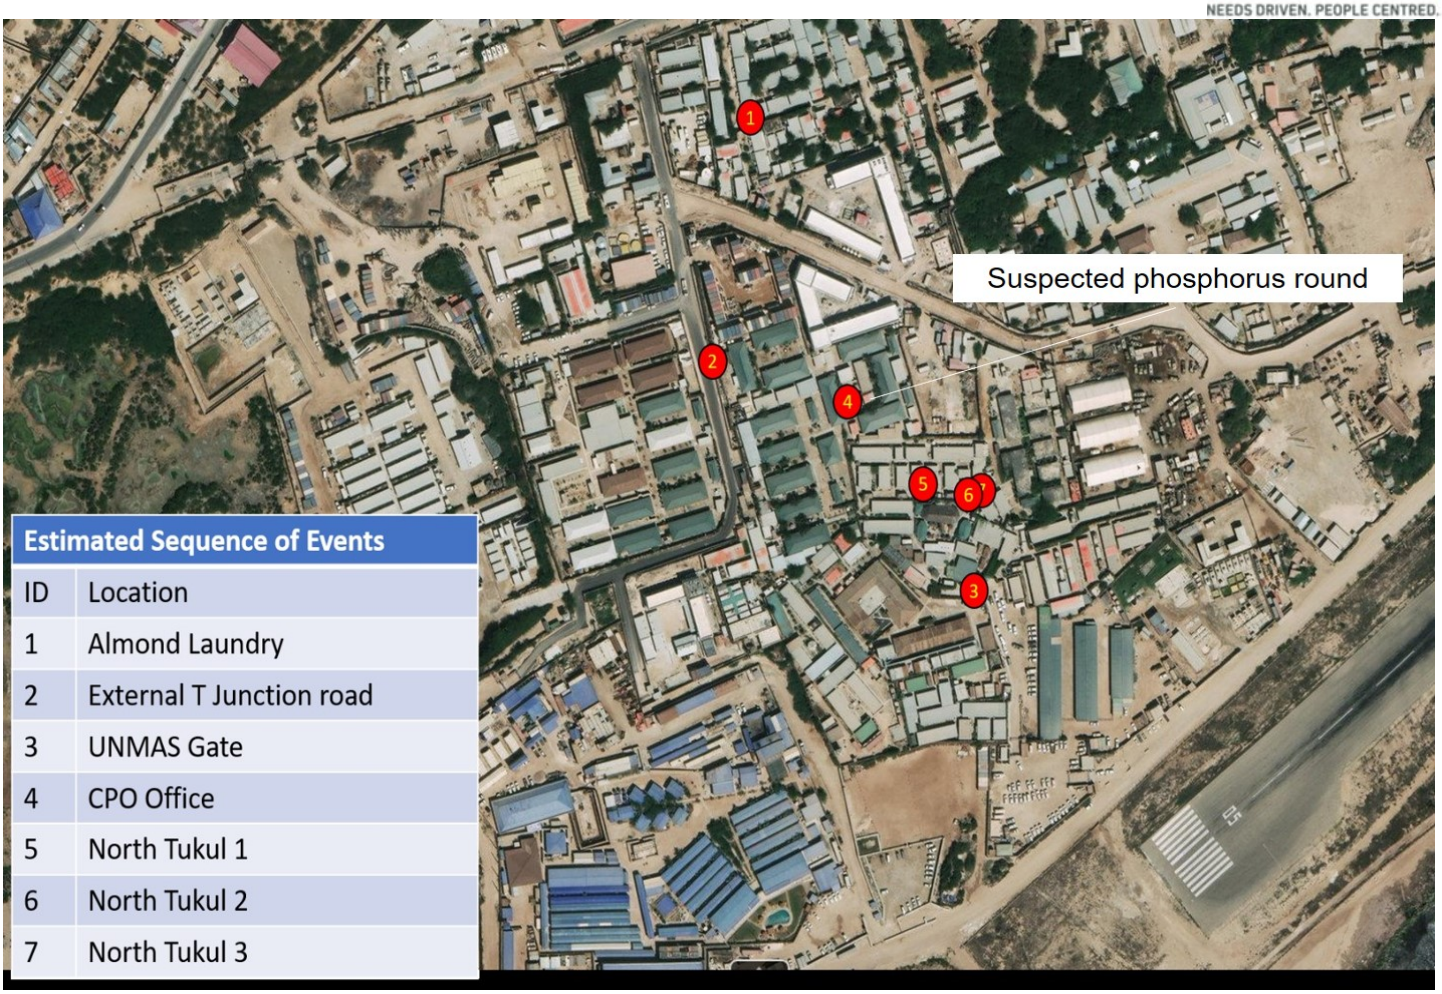
The below graphic illustrates the currently assessed chain of events. Seven mortar rounds are confirmed as having been fired. The first round is assessed as having landed near the Close Protection Officer (CPO) office, followed by one round along the road leading to the T-Junction.

The third impact was heard south, likely near UNMAS gate.

The four last impacts occurred in rapid sequence in close proximity to Tukul.

Estimated Sequence of Events	
ID	Location
1	Almond Laundry
2	External T Junction road
3	UNMAS Gate
4	CPO Office
5	North Tukul 1
6	North Tukul 2
7	North Tukul 3

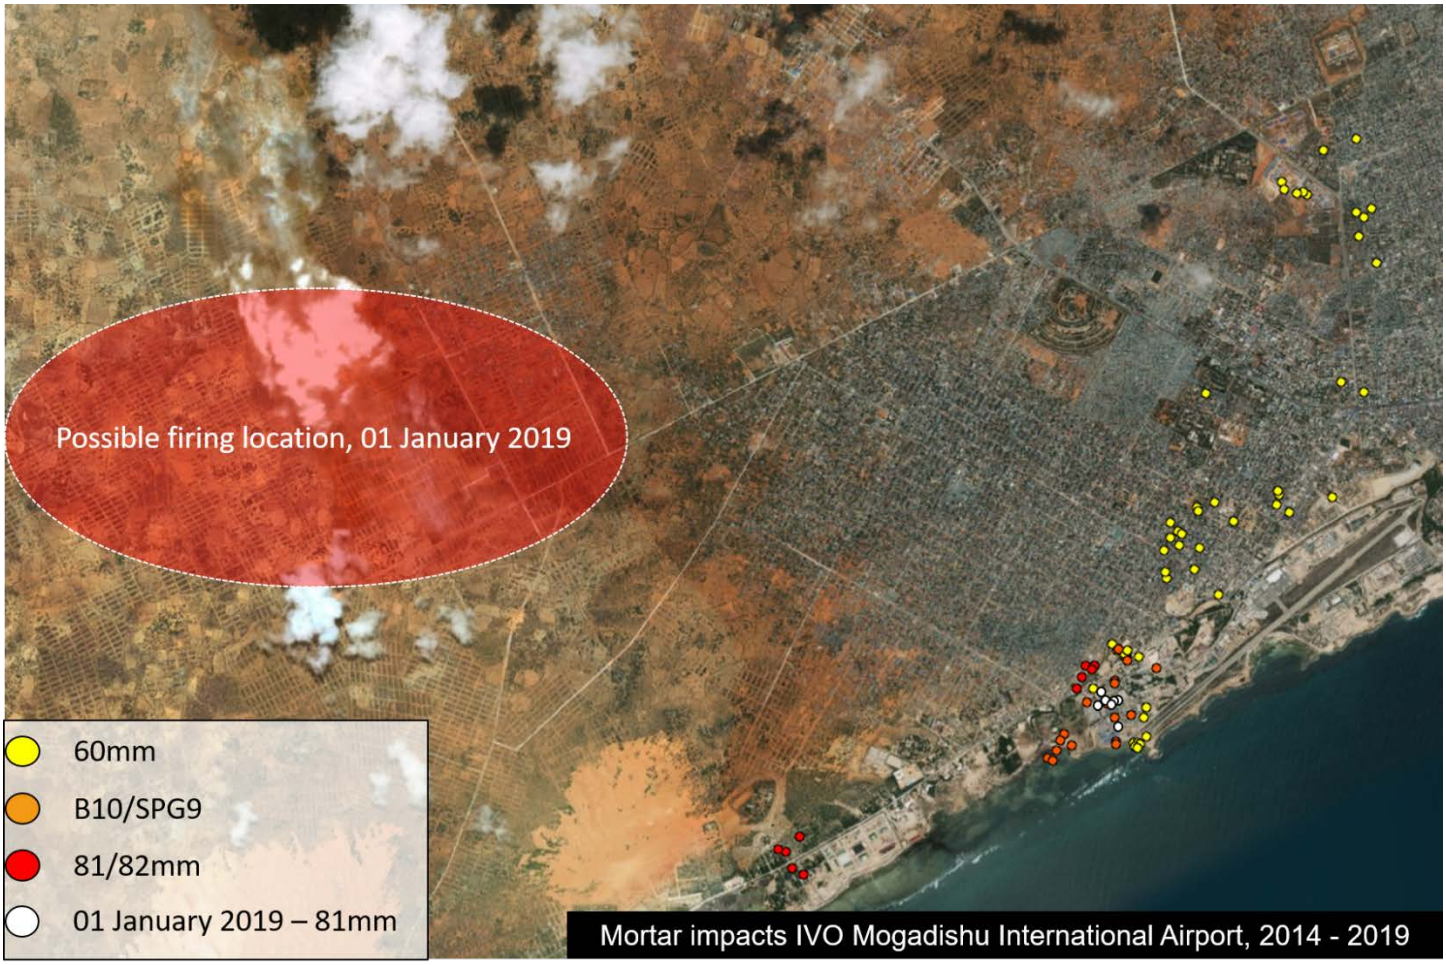
The existence of several high structures within the compound may have provided aiming markers to the team. This is suggested by the location of the impacts post-bracketing, all located in close proximity of each other. The use of a nearby elevated structure as aiming marker is currently assessed likely.
